TESTS OF LIQUID HELIUM RELEASES AT BNL, FNAL AND CEBAF

Helium Gas Release Tests in RHIC 1012 Q5 Tunnel

OXYGEN DEFICIENCY HAZARD INDUCED BY HELIUM RELEASE IN ACCELERATOR TURNEL*

SIMULATION OF ACCIDENT INVOLVING THE RELEASE OF LIQUID HELIUM INTO THE MAIN RING TUNNEL

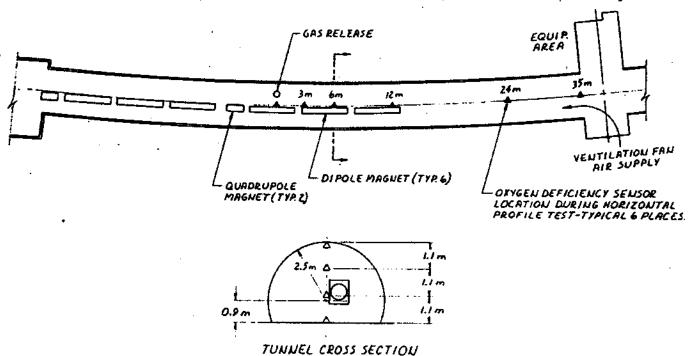
Figure 1. Plan and cross-section views of test area which is a section of the CBA tunnel. Magnets shown are those used in the Full Cell Test.

The tests were carried out at CBA Sextant V East Injection/Ejection area during initial stages of magnet installation for the "Full Cell" test program. The tunnel cross-section is shown in Figure 1 and has an area of approximately 14 sq. meters. Off sensors were located in positions as shown in the plan view of Figure 1. The sensors were mounted at the highest point of the ceiling, approximately 3.3 meters from floor level for the horizontal flow tests and were later grouped and arranged vertically as shown in the tunnel cross-section of Figure 1 to measure floor to ceiling oxygen gradients.

During the series of tests helium was released into the tunnel at flow rates of 1, 5, 10 and 15 grams/second with ODM sensors located as shown in the plan view in Figure 1. A composite of the ODM graphical records at 15 g/s flow, is shown in Figure 2. Tests showed that a release rate of 15 g/s produced results that were typical of release rates of 5 and 10 g/s with respect to both the horizontal propagation velocity and the O2 concentration in still air at steady state conditions. From this data the following conclusions can be drawn:

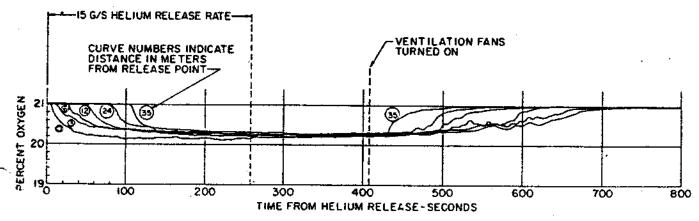
Figure 2

A. The ODM sensors have a time delay of about 5 or 6 seconds from the arrival of helium at the sensor until the sensor output begins to rise.

- B. Typical rate of change is 0.02 percent oxygen per second.
- C. The horizontal propagation velocity of the helium front was typically 0.3 m/s.
- D. The above characteristics are acceptable for our intended use, i.e., to warn of an O₂ deficiency in a relatively short time after relesse of helium into the tunnel.

- E. For all flow rates, including the highest (15 g/s), the O₂ level never dropped below 20% at the ceiling level where the sensors were located. (OSHA requires a minimum of 19.5% for continuous occupancy.)

OXYGEN CONTENT AT TUNNEL CEILING AS A FUNCTION OF TIME FOR SENSORS AT VARYING DISTANCES FROM THE HELIUM RELEASE POINT

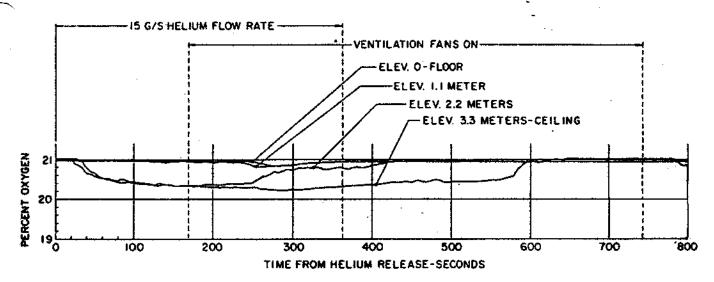
Figure 3

Following the tests with the ODM sensors spread horizontally at ceiling level, four sensors were relocated in the vertical grid shown in the tunnel cross-section of Figure 1. The grid was located 6 meters up the tunnel from the helium release point toward the air supply from the fans. The helium release rate was 15 g/s for this test. The response of the sensor (see Figure 3) at the ceiling (elev. 3.3 m.) and the sensor at elev. 2.2 m. were nearly the same until the fans were turned on. In response to the faus, the sensor at elev. 2.2 m. showed a slow increase in O2 concentration and at about that same time some slight amounts of helium were detected by the sensors located at the floor (elev. 0) and at elev. 1.1 m. It can be assumed that the fans caused turbulence which mixed the helium and air, causing

OXYGEN CONTENT AS FUNCTION OF TIME FOR SENSORS AT VARYING ELEVATIONS IN CBA TUNNEL AT 6 METERS FROM HELIUM RELEASE POINT

the O2 concentration to rise at the 2.2 m. elevation while causing it to fall at the two lower elevations.

These test results indicate that the belium does tend to rise rather than mix evenly throughout the tunnel cross-section. This is convenient from the standpoint of detecting oxygen deficiency due to helium leakage because a detector located at the ceiling will always indicate the lowest 02 concentration and it is unnecessary to sample at other elevations. This would not be the case if significant quantities of inert gases of higher density than air were used in the tunnel.
